21 July 2021

## General Motors Position Statement Bumper/Fascia Replacement with Advanced Driver Assistance Systems (ADAS)

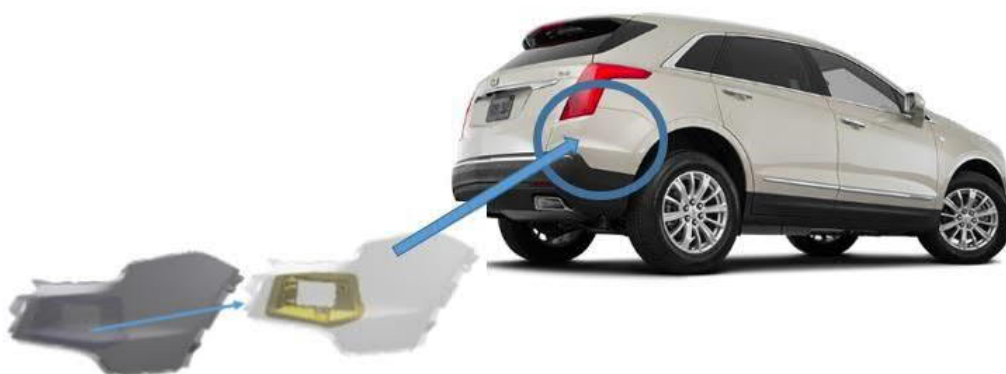
Figure 1.1

Depending on vehicle build configuration, the Bumper/Fascia system may have ADAS sensors attached to the inner surface that are not visible from the exterior of the vehicle (Please refer to Figure 1.1). GM is limiting repairs to these Bumper/Fascia systems on vehicles equipped with ADAS.

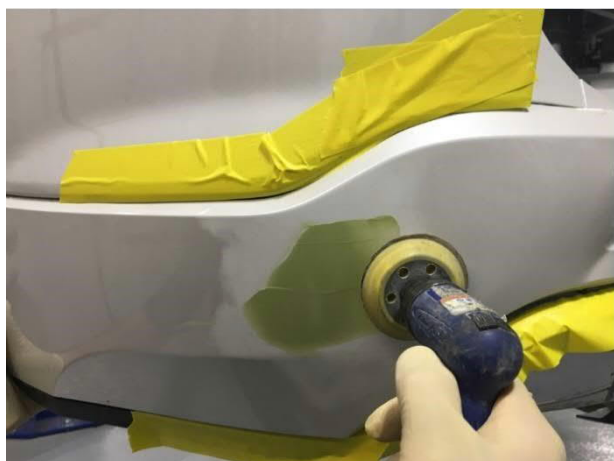
Any Bumper/Fascia equipped with ADAS(s) that requires substrate repair must be replaced.  
An example of substrate repair is shown in Figure 1.2
